Licence No.: 09E0427
NGR: 27987.079/97687.085
RMP Nos: KE051-002---, KE051-012---,
ÆGIS Ref.: 177-10

Archaeological Assessment and Instrument Survey on the Great Blasket Island, Co. Kerry

**Report Author
and Licence Holder:** Frank Coyne BA MIAI

Date: February 2010

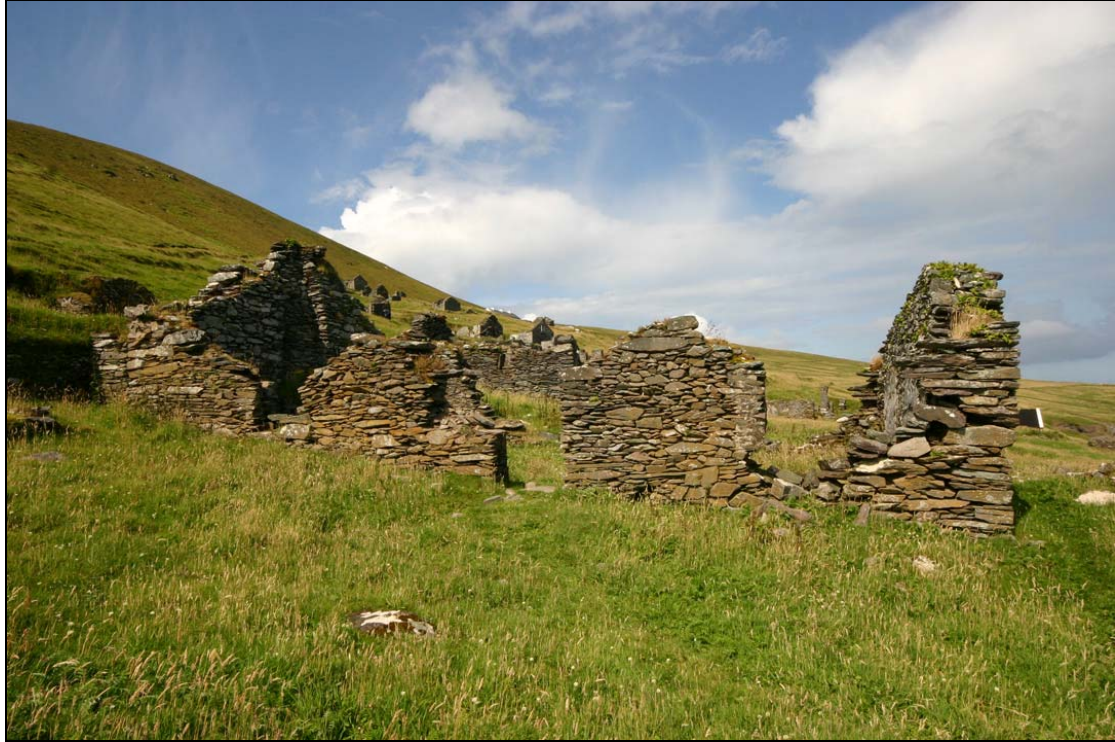
Plate 1. Aegis House 1/GB 8

This structure was surveyed in September 1991 and was identified as a house and outhouse in poor condition; the rear wall and upper part of the front wall had collapsed. A narrow gable window to the sleeping loft and five niches in the hearth wall were also recorded. The earliest map reference was from 1916 (presumably from the Congested District Board Map). The Valuation Office data of 1902 (map no. 1k (iii)) recorded the tenant as a Michael Shea, who had been recorded as living in Site 10 in the 1901 census. The census data of 1911 also states a Michael Shea as the tenant as well as the house, classified as a Grade 3 structure, consisting of two rooms and two windows. The outhouse was not recorded during the 1911 census, however it did appear on the 1916 Congested District Board (CDB) data map (map no. 4), indicating the period of 1911-1916 as the period of construction. The CDB data, which designated this property as Rental no. 20, also noted that the occupier was Michael Shea with full tenancy. In *An Blascaod Mór* (Pádraig Tyers, Dún Chaoin 1991), map no. 6, the occupier is Micheál O Sé ('Faight'). Building No. 5 also appeared in a photograph, taken in

The January 2003 report identified the Condition Grade of this structure as Grade C and the Structural Configuration as Type 4 (opes visible). The barge stones of both gables were missing and required consolidation. The south gable was in better condition and partially embedded in the hill side. The top of the north gable had collapsed. The north wall had very little connection with its side walls due to partial collapse. Both gable walls required stitching to the two side walls. The hearth was still evident, although the breast and chimney had collapsed leaving the flue exposed. Four niches were present in the south elevation. The west wall had almost completely collapsed. A door ope was present in the east elevation. The walls had collapsed below the lintel level (no lintels were remaining).

Internally, most of the applied render had been washed away. Pockets for the joists in the east and west walls showed the former existence of a hearth loft. There was no surviving evidence showing the existence of a sleeping loft. Two window opes were visible in the east elevation even though the wall had collapsed below the lintel level. The window ope at the north end of the building had been torn apart due to the possible movement of the north gable and the loss of the lintel and sill. The window ope at the south possessed a stone sill. The roof was missing.

It was suggested that settlement may have been occurring as it appeared that the north gable was moving and had caused the east and west walls to partially collapse. This falling gable tore apart the side walls at their openings where the movement forces were greatest.

The Paul Arnold Architects 2009 preliminary report identified no significant change in the condition of Building 5, but did highlight the presence of very loose stone on the top of the walls.

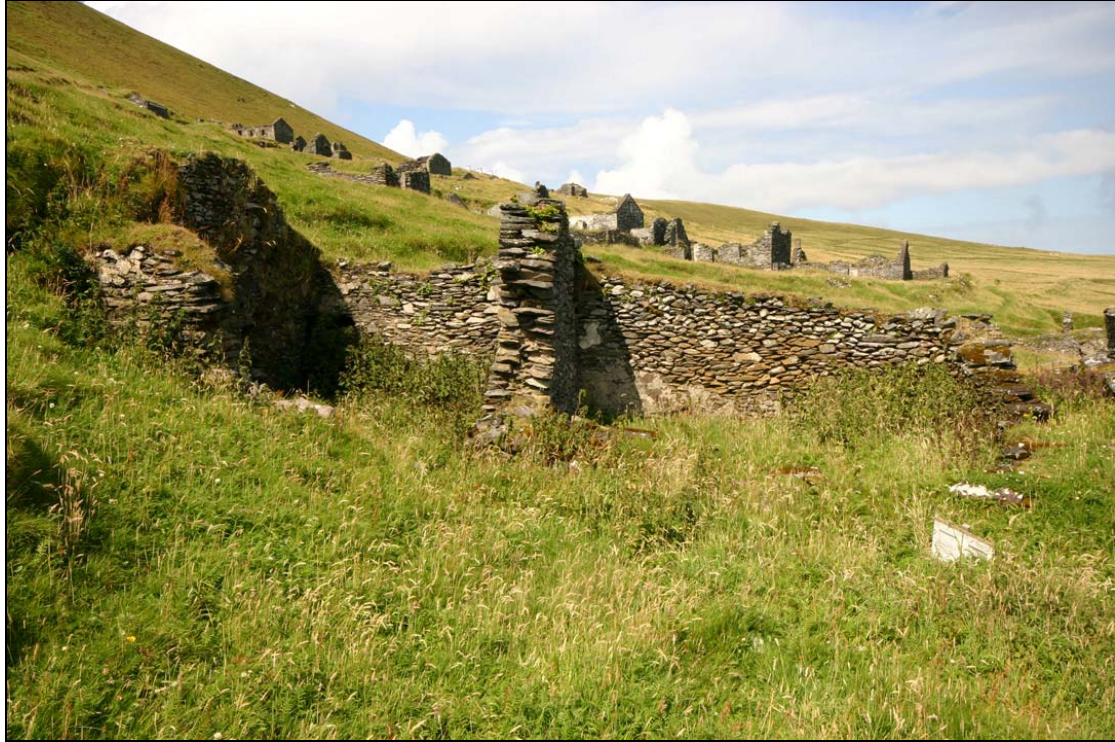
Plate 2. Aegis House 2/GB 9

This structure was surveyed in September 1991 and was identified as a house in poor condition; the front wall had collapsed as had part of the north gable. It was originally one house being extended into two dwellings certainly by 1901 when Jeremiah Shea occupied the new southern end. A drain ran between the two structures and evidence for lofting was seen in the southern unit. No evidence of hearths was seen. The first map reference is the 1st Edition OS map of 1846. The Valuation Office data of 1850 (map no. 1n) records the structure as Grade 3c with dimensions of 15' length, 14' breadth and 5' in height. This data also records the tenant in 1850 as Michael Sullivan, in 1859-1860 as Eugene Dunleavy, in 1860-1882 as James Guiheen, in 1885 as Patrick Guiheen Flint and in 1901 as Michael Guiheen Flint.

The January 2003 report identified the original dimensions, of the north unit, as 4.4m in length, 4.2m in breadth and 1.5m inn height. It also identified the Condition Grade of this structure as Grade D and the Structural Configuration as Type 4 (Opes visible). All the gables were present to some degree though no barge stones were present. It was recommended that the gable walls be consolidated and stitched to their flanking side walls. A drain was evident between H6a and H6d which had been filled by rubble from the falling gables. It was suggested, if possible, to remove the rubble. Niches were evident in the south gable of H6b and H6e even though no hearths were evident in any of the units. Walls H6a, H6b and H6c appeared to have originally formed a single unit while H6d and H6e formed a second unit to which was attached a cow shed with a lean-to roof. The east elevation was in a state of ruin. In H6b, on the east elevation, there appeared to be evidence of a blocked up door ope. Generally the upper portions of the remaining walls had collapsed and it was recommended that these should be consolidated. It was also suggested that the side walls of each of the units may have to be tied together and stitched to the cross gables. Only one small window ope was evident in the east elevation of H6b which had a stone lintel. The window in H6b had a stone sill. No roof was present and there was evidence of a lean to roof attached to the northern gable of H6c. The high priority work identified concerned the gable wall between H6a and H6b as it was about to fall. It was also suggested to tie in the loose stone within the north gable of H6c to prevent the collapse of the remaining gable. Further investigation was suggested to discover if settlement was occurring along the whole length of the house and to assess if the rubble between H6a and H6d was adding strength to the

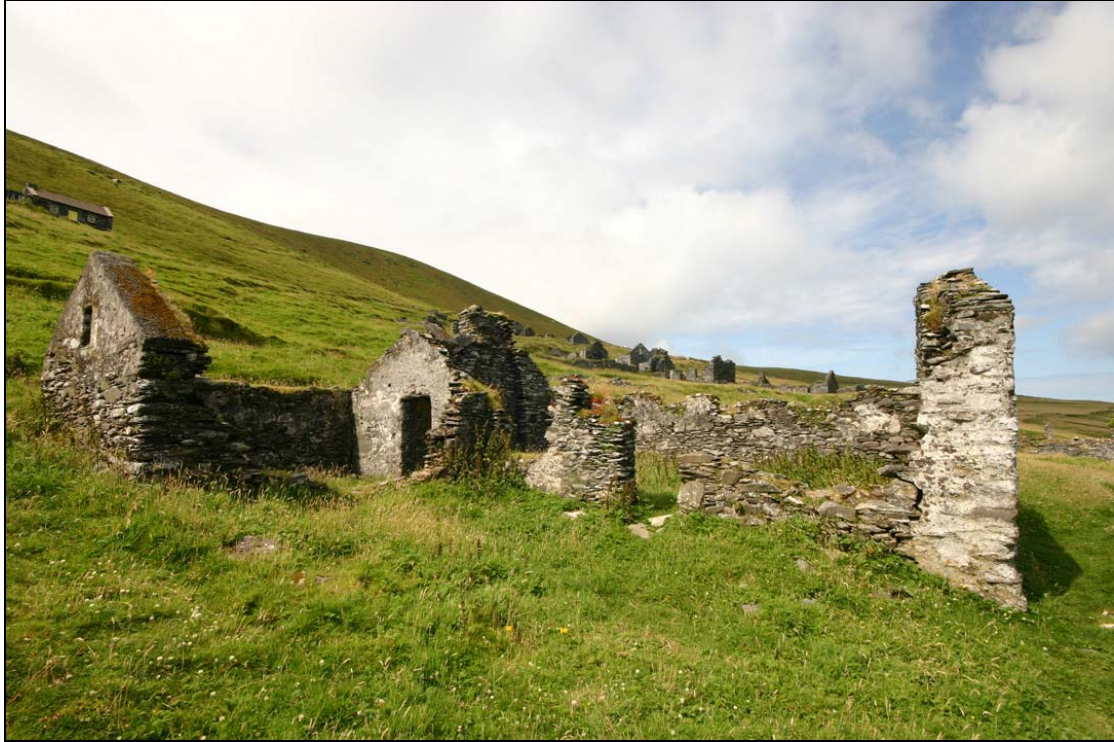
Plate 4. Aegis house 4/GB 10

These structures were surveyed in 1991 and were identified as a house (Building No. 8) and extension (Building No. 7) in fair condition; with the upper portion of the front wall collapsed but with all gables intact. The extension post-dated the house with the opening from building 8 to 7 crudely made in an effort to preserve the front window. The hearth recess, with three niches in the hearth wall, and evidence of a sleeping loft in both buildings were also noted. The earliest map reference was the 1895 map. There was no Valuation Office data but they were recorded in the 1901 census as a Grade 2 structure consisting of two rooms, three windows and occupied by Eugene Sullivan. A cow house is also recorded in association with this property, possibly Building No 9 (see below), in 1901 though in 1911 only a fowl house is recorded. In the 1911 census they were classified as a Grade 3 structure with two rooms, but now with only two windows, and was occupied by Eugene Sullivan. The CDB data (map no. 6) of 1916, which designated these as Rental no 11, noted that the

The January 2003 report of Building 7 did not list any Condition Grade or Structural Configuration Type. Both barge stones were present, although the barge stone of the west elevation was partially missing. The west gable butts against the east wall on H8. There was a gable window in the east wall. Stitching of the east gable was required as its stability had been reduced by the collapse of the north wall.

A door opening, which possessed a stone lintel, was cut through the west gable giving access to H8. The north wall had collapsed and it was suggested that the remains should be consolidated. The south wall was in good condition and embedded in to the hill side with none of it extending above ground. There was evidence of the applied render but this was being washed away. There were no window openings in H7 although it was possible that at one time an opening existed in the north elevation which would explain the way the wall had collapsed to approximately sill level. No sills were evident, nor was the roof present. The high priority work identified concerned the remaining portion of the north wall as it was seen to be separating from the north gable and there was a great deal of loose stone which would need to be rectified before further collapse occurred. It was also suggested that the concrete barge on the west gable should be bedded in hydraulic mortar as it was about to fall. Further investigation was suggested to discover if settlement was occurring which may have explained the separation and collapse of the north wall.

The January 2003 report of Building 8 did not list any Condition Grade or Structural Configuration Type. Both gables were intact and possessed pieces of their barge stones. Three niches were identified in the south wall. The sides of the chimney stack remained however the hearth and chimney had collapsed. The south wall was partially embedded in the hill side. A gable window was present in the north wall. Stitching of both gables was

needed. A door ope was present in the east elevation although its lintel was missing. The door ope through to H7 possessed a stone lintel. The upper portion of the east and west elevations had collapsed and needed consolidation. There was evidence of a sleeping loft from the gable but not from the side walls. Two window opes were evident in the east elevation although the wall had collapsed below lintel level. Both windows possessed their stone sills but their timber window boards were missing. No roof was present.

The high priority work identified concerned the north gable which was generally cracked, many of which were identified as serious to the stability of the wall. It was also suggested the upper portion of the south gable be stitched to the side walls as its stability was in doubt. Further investigation was suggested to discover if settlement was taken place which may explain the serious cracks in the north walls and why the window had collapsed to sill level, with a crack running down its length.

Further to this, the Paul Arnold 2009 preliminary report identified the northern, downhill gable was heavily fissured. Also the hillside gable was leaning dangerously: as this is adjoining a route which is used by many visitors. The repair of this gable was identified as a priority and that, pending repair, access to the building should be prevented by means of appropriate fencing and danger signs.

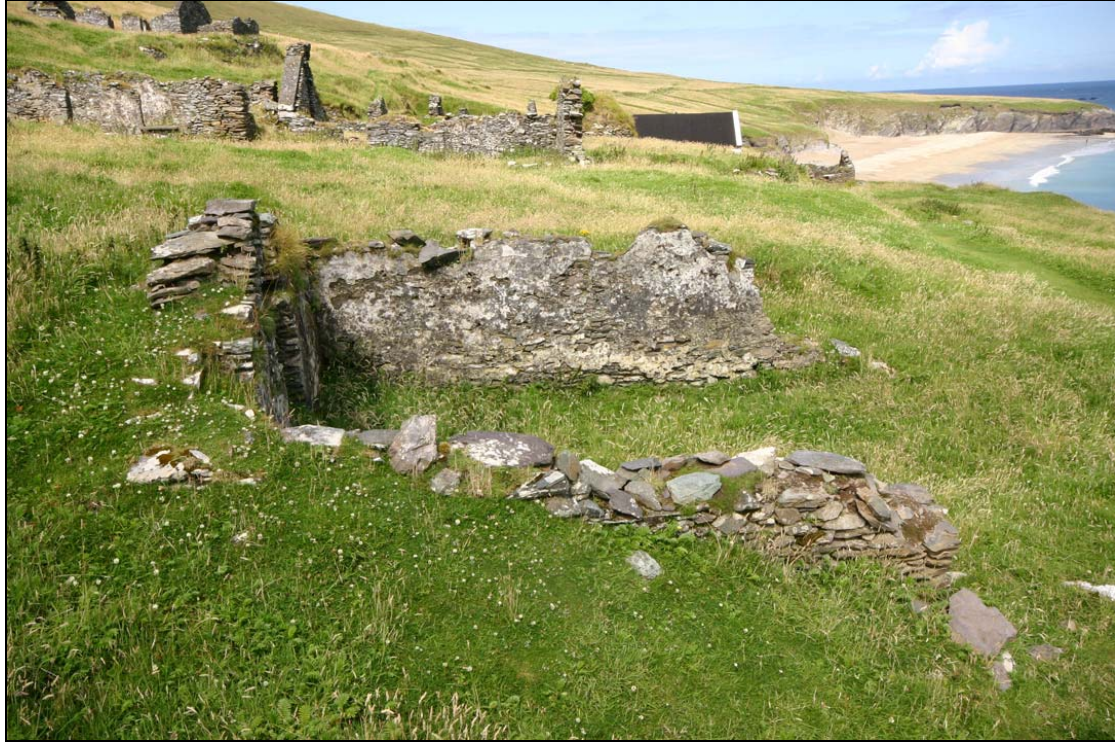
Plate 6. Aegis house 6/GB 11

This structure was recorded in September 1991 and was identified as a house in poor condition; the side walls were in a partially collapsed state with most of the northern half destroyed. The hearth wall was almost intact, with two niches, which was clear evidence of a hearth loft, and only the base of the fireplace. The earliest map reference is from the 1903 valuation map.

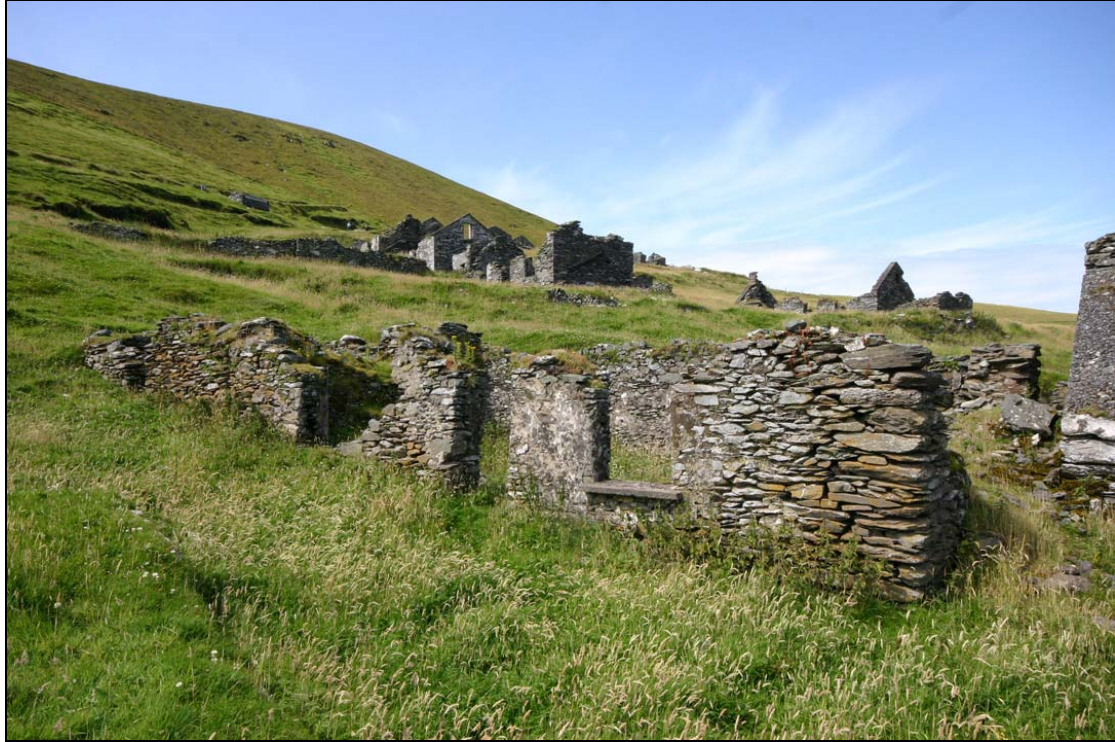
Plate 9. Aegis house 9/GB 12

The 2009 Preliminary report identified that the stones on the right hand side of Building 15/16 were loose and the downhill gable was detaching itself from the side walls.
