Licence No.: 09E0427
NGR: 27987.079/97687.085
RMP Nos: KE051-002---, KE051-012---,
ÆGIS Ref.: 177-10

Archaeological Assessment and Instrument Survey on the Great Blasket Island, Co. Kerry

**Report Author
and Licence Holder:** Frank Coyne BA MIAI

Date: February 2010

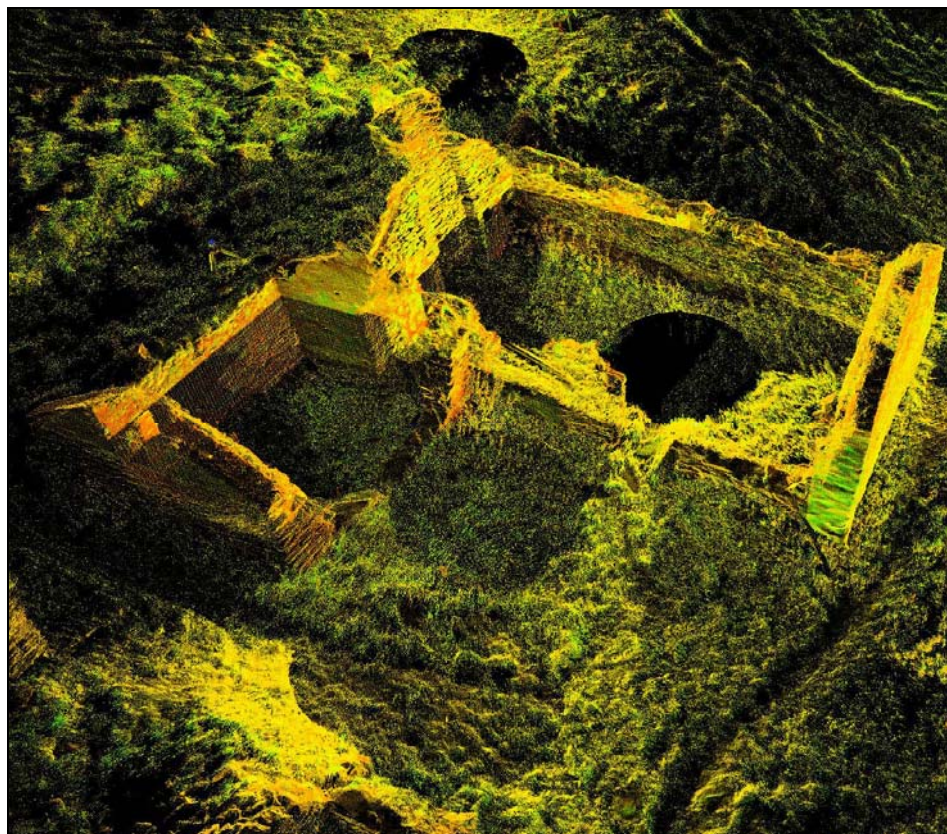
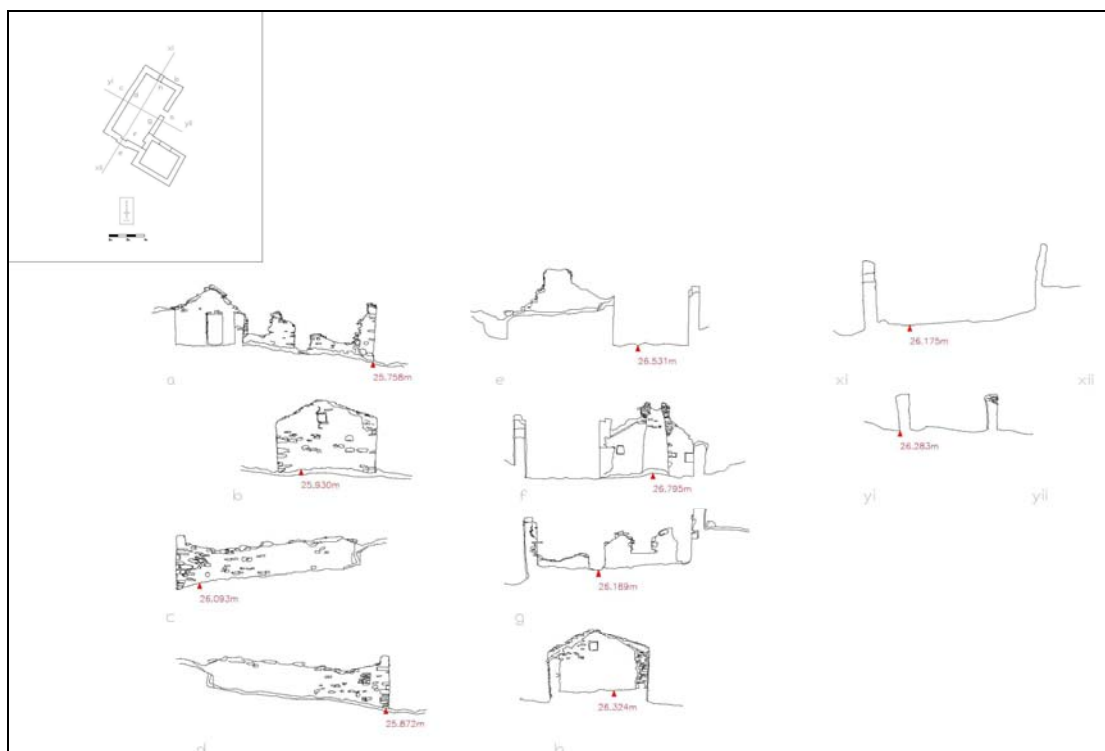
The January 2003 report of Building 7 did not list any Condition Grade or Structural Configuration Type. Both barge stones were present, although the barge stone of the west elevation was partially missing. The west gable butts against the east wall on H8. There was a gable window in the east wall. Stitching of the east gable was required as its stability had been reduced by the collapse of the north wall.

A door opening, which possessed a stone lintel, was cut through the west gable giving access to H8. The north wall had collapsed and it was suggested that the remains should be consolidated. The south wall was in good condition and embedded in to the hill side with none of it extending above ground. There was evidence of the applied render but this was being washed away. There were no window openings in H7 although it was possible that at one time an opening existed in the north elevation which would explain the way the wall had collapsed to approximately sill level. No sills were evident, nor was the roof present. The high priority work identified concerned the remaining portion of the north wall as it was seen to be separating from the north gable and there was a great deal of loose stone which would need to be rectified before further collapse occurred. It was also suggested that the concrete barge on the west gable should be bedded in hydraulic mortar as it was about to fall. Further investigation was suggested to discover if settlement was occurring which may have explained the separation and collapse of the north wall.

The January 2003 report of Building 8 did not list any Condition Grade or Structural Configuration Type. Both gables were intact and possessed pieces of their barge stones. Three niches were identified in the south wall. The sides of the chimney stack remained however the hearth and chimney had collapsed. The south wall was partially embedded in the hill side. A gable window was present in the north wall. Stitching of both gables was

needed. A door ope was present in the east elevation although its lintel was missing. The door ope through to H7 possessed a stone lintel. The upper portion of the east and west elevations had collapsed and needed consolidation. There was evidence of a sleeping loft from the gable but not from the side walls. Two window opes were evident in the east elevation although the wall had collapsed below lintel level. Both windows possessed their stone sills but their timber window boards were missing. No roof was present.

The high priority work identified concerned the north gable which was generally cracked, many of which were identified as serious to the stability of the wall. It was also suggested the upper portion of the south gable be stitched to the side walls as its stability was in doubt. Further investigation was suggested to discover if settlement was taken place which may explain the serious cracks in the north walls and why the window had collapsed to sill level, with a crack running down its length.

Further to this, the Paul Arnold 2009 preliminary report identified the northern, downhill gable was heavily fissured. Also the hillside gable was leaning dangerously: as this is adjoining a route which is used by many visitors. The repair of this gable was identified as a priority and that, pending repair, access to the building should be prevented by means of appropriate fencing and danger signs.

Rated as regionally important. Maintenance and restoration suggestions are (a) stonewalls should be stabilised and restored following best conservation practise (b) no material changes should be done to structure and the curtilage except for restoration works. (c) restoration works shall be subject to planning permission. Ruin may be open to the public if this does not impinge on the preservation and appreciation of the structure and the setting.

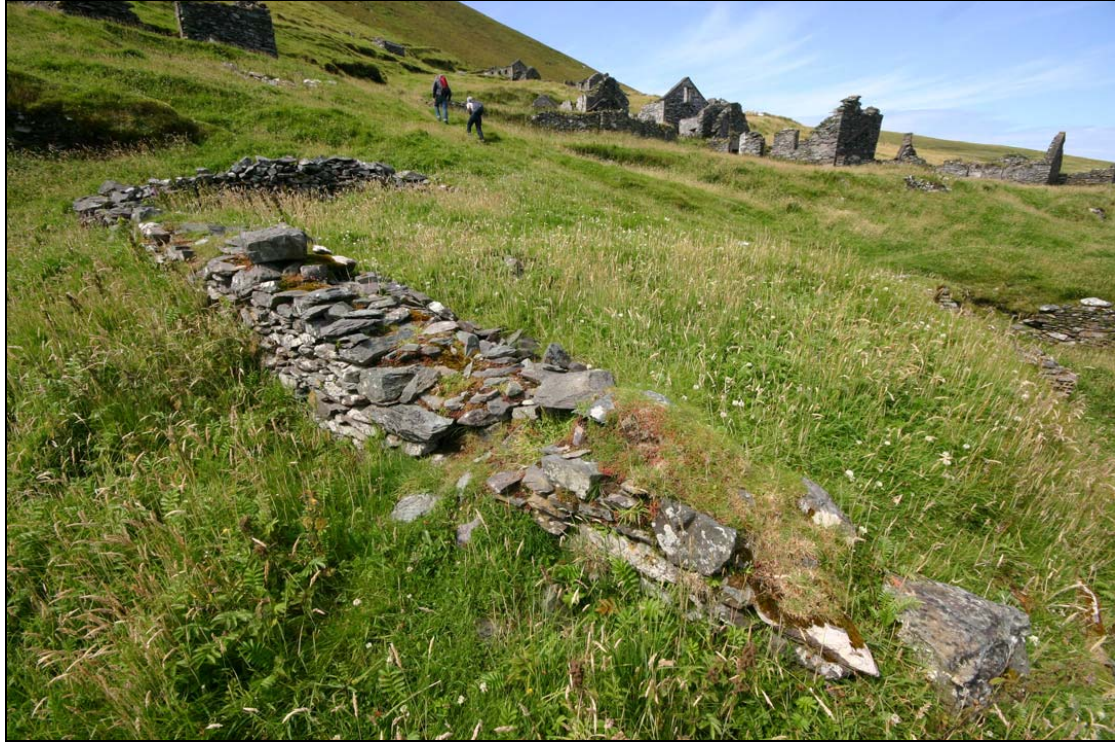
Plate 8. Aegis house 8/GB 10e

The January 2003 report identified the Condition Grade of this structure as Grade F and the Structural Configuration as Type 5 (Ruined). Only the south wall, which was embedded into the ground, partially survived. There was no remaining evidence of the north gable. Only the

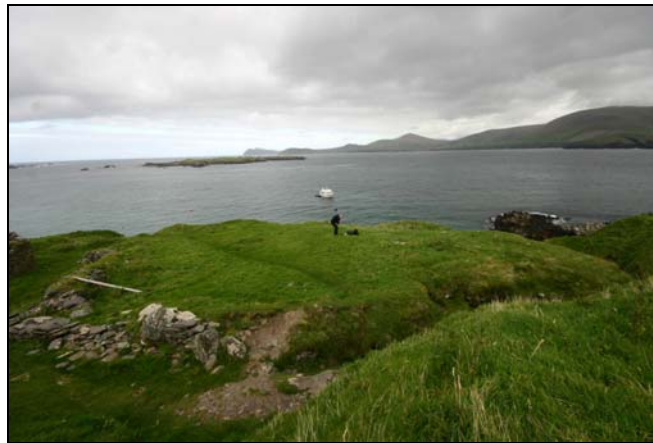
Plate 16. *Rinn an Chaisleáin*, from W

This is recorded in the Dingle Peninsula Archaeological Survey (Cuppage 1986, 375) as a small headland on the NE side of the island, and is reputedly the site of a castle. There are no known documentary references to a castle here, nor does it appear on any of the early maps. The castle is traditionally associated with Piaras Feiritéar, who sought refuge here around 1641, but was subsequently captured and executed. During the recent survey, a number of openings in the ground were identified here, where flat slabs have become displaced, revealing a two narrow stone built chambers. Their function is, as yet, unknown.

- **Rinn an Chaisleain**-The displaced slabs should be replaced. Because they appear to cover a dry-stone built passage or chamber, it is important that they should be archaeologically investigated, in order to ascertain their nature and extent. They may in fact be an indication of a souterrain, so it would also be useful in assessing the safety of the site, and identifying potential future areas of collapse. The archaeological works should be carried out by hand, working within the confines of the possible structure, in order not to disturb burials in the vicinity. At present the burials appear to be located to the east of the possible souterrain.

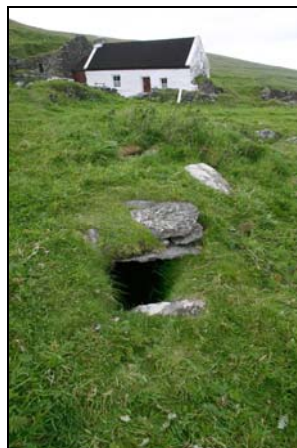
Plate 17. *Rinn an Chaisleáin*, openings from S

No skeletal material was noted in the openings. It is entirely possible that these represent portions of a souterrain.

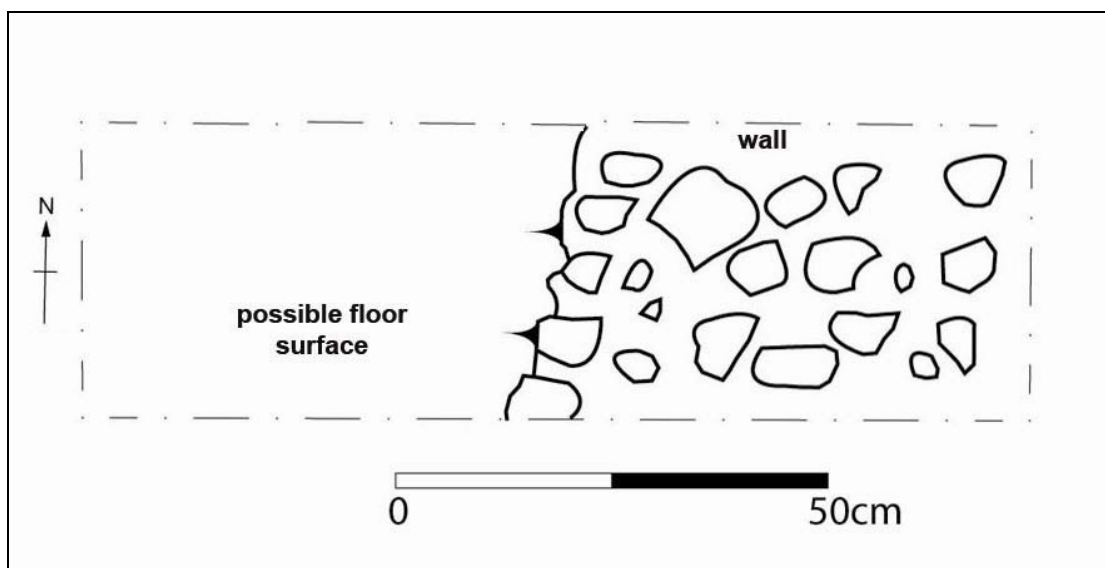
Figure 36. Plan of trench 1, H5/ GB10a

An area of stone collapse 0.4m east-west and extending beyond the width of the trench.

This wall was 0.75m wide and extended beyond the width of the trench. It was constructed of loose rubble, with no facing stones visible. It was 0.7m high.

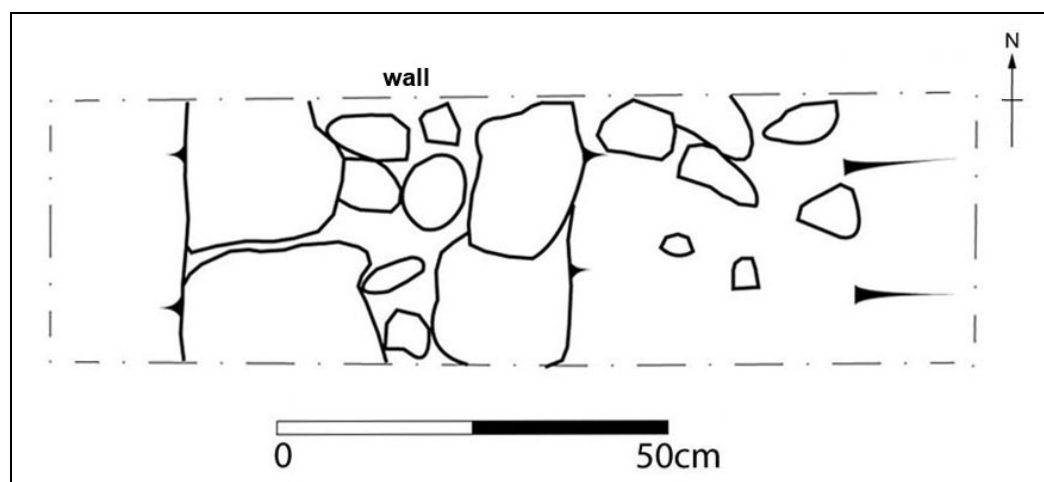
Figure 38. Plan of trench 1, H6/GB 11

An area of stone collapse 0.6m east-west and extending beyond the width of the trench.

This wall was 0.60m wide and extended beyond the width of the trench. It was constructed of facing stones and a rubble core. It was 0.3m high.

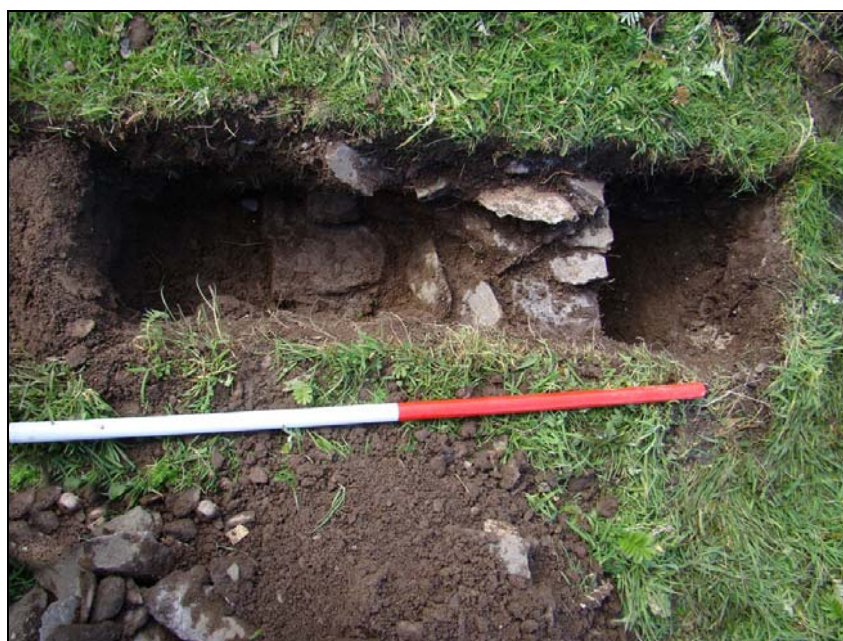
Plate 20. H6/GB 11, trench 2, from E

This possible floor, a layer of silty sand extended across the northern side (interior of the structure). No depth was ascertained.

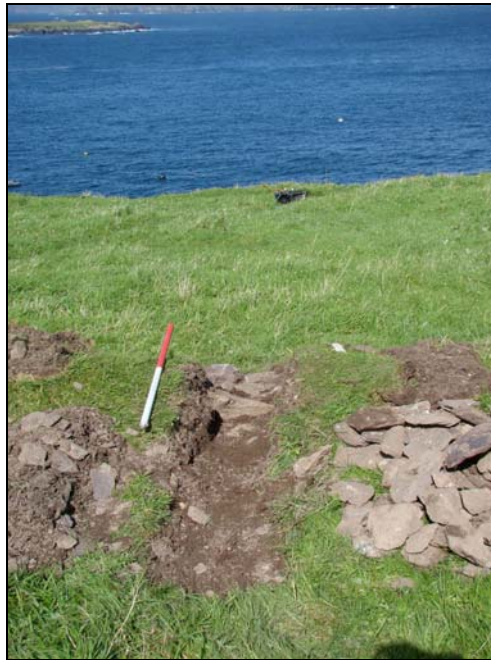
Plate 21. H7/GB 10d, trench 1, from W

This wall was 0.60m wide and extended beyond the width of the trench. It was constructed of facing stones and a rubble core. It was 0.1m high externally, with facing stones and a rubble core.

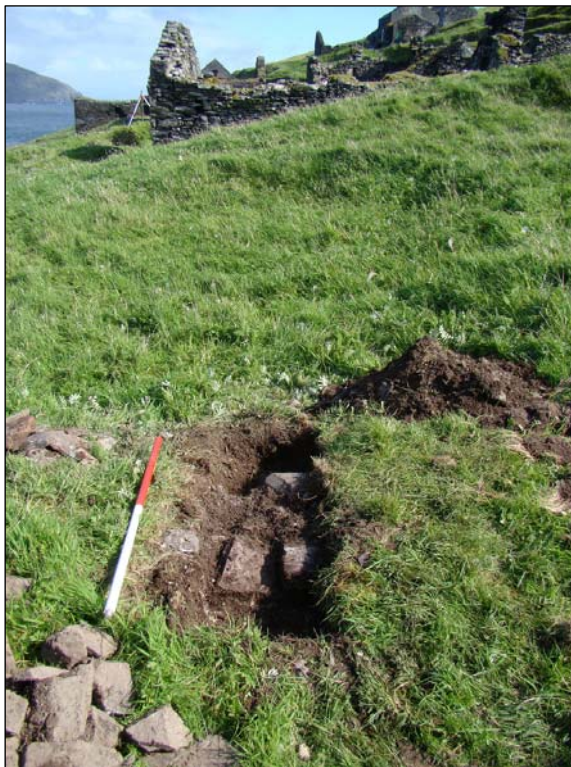
Plate 22. H7/GB 10d, trench 2, from W

Trench 2 was located across the southern wall of this structure. This wall was visible as a 1m high and 0.45m high grass-covered hump. The trench measured 1.2m north-south by 0.40m east-west. .

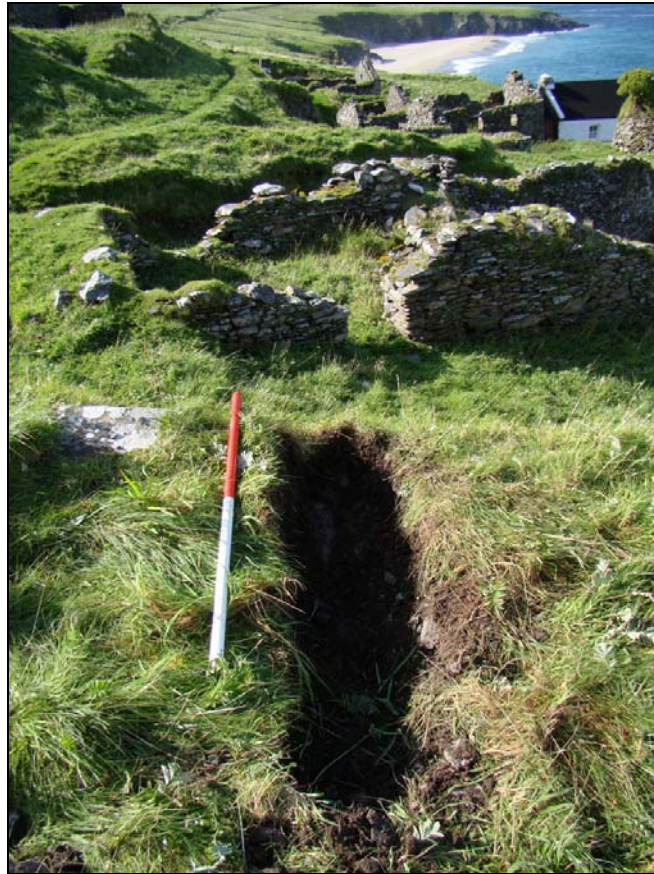
Plate 23. H8/GB 10e, trench 1, from S

This is a rectangular structure located on a level shelf. The S wall appears to be the only original feature; the other walls appear to be recently rebuilt.

An area of loose stone and gravel in a matrix of topsoil, with occasional larger stones visible. It measures 0.60m north-south and is 0.15m deep.

House No.	Paul Arnold Architects condition grade and brief summary of report
H8/KCC 10e/OPW 14	Condition Grade F. Only the S wall partially survives, loose masonry on the S elevation should be consolidated.
H7/KCC 10d/OPW 13	Condition Grade E. The walls are in ruins with only the footing remaining.
H2 & 3/KCC 9/OPW 6 & 7	Condition Grade D gables present, no barge stones. The gable wall is about to fall, investigation required to ascertain if settlement is occurring along the length of the house.
H4/KCC 10/OPW 7	Condition Grade D The N wall has collapsed and should be consolidated.. Stitching of the E gable is required. The remaining portion of the N gable is separating from the N gable. The concrete barge on the W wall is about to fall. Investigation required to ascertain if settlement is occurring, which might explain the separation and collapse of the N wall.
H6/KCC 11/OPW 11	Condition Grade D .Only S gable remains, wall tops should be consolidated. N portion of the building has been destroyed.

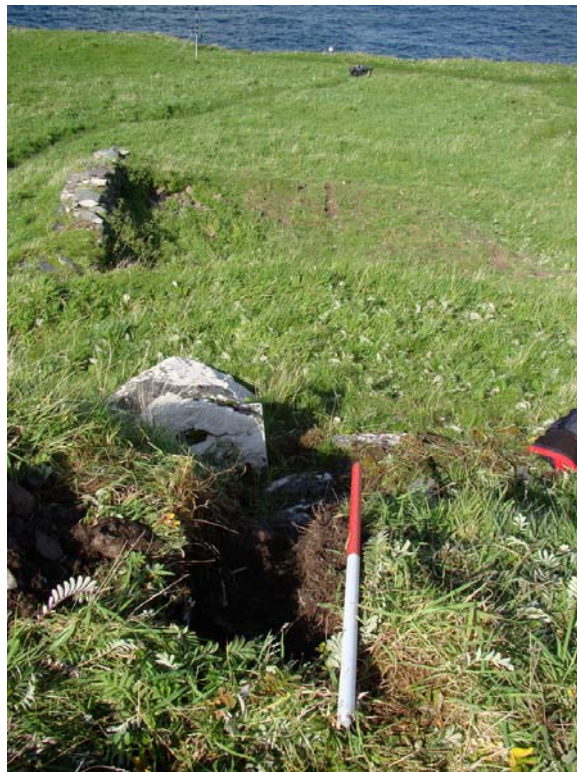
Plate 24. H8/GB 10e, trench 2, from W

An area of loose stone and gravel in a matrix of topsoil, with occasional larger stones visible. It measures 0.60m north-south and is 0.15m deep. These larger stones appear to function as a revetment, and are in excess of 0.3m deep.

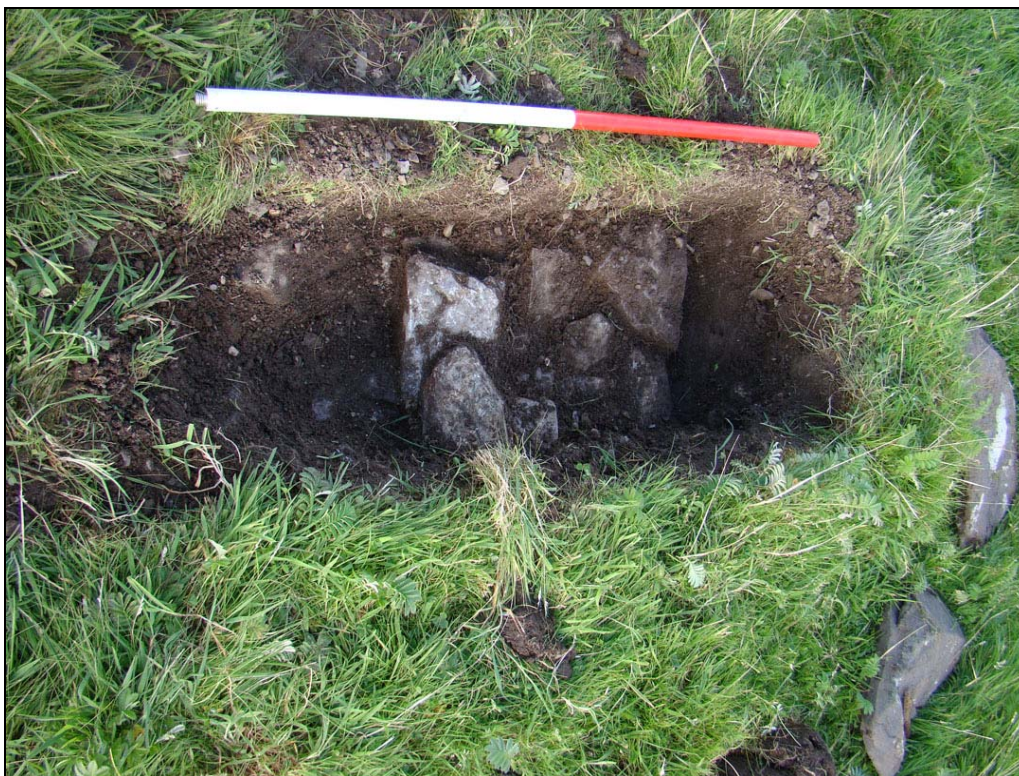
Plate 25. H14/GB 25a, trench 1, from S

This wall was 0.55m wide and extended beyond the width of the trench. It was constructed of facing stones and a rubble core. It was 0.2m high. It was constructed of facing stone with a rubble core.

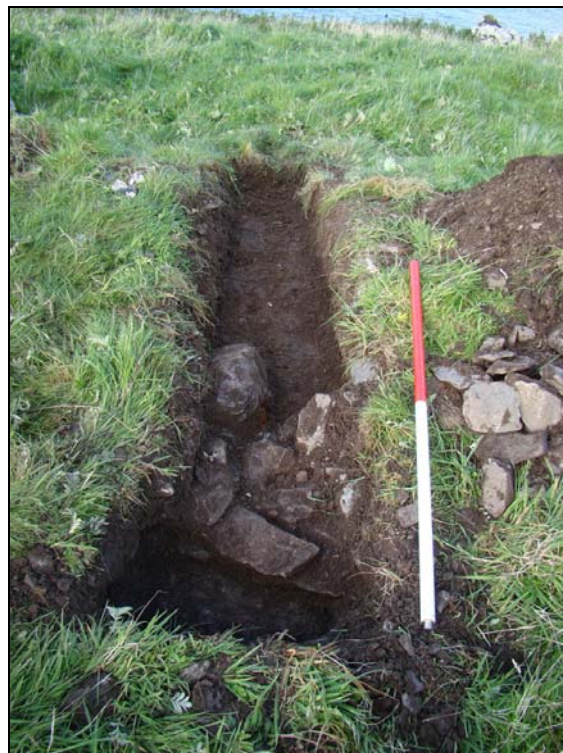
Plate 27. H14/GB 25a, trench 3, from W

Context No.: 39
Context Type: Wall
 This wall was 0.65m wide and extended beyond the width of the trench. It was constructed of flat slabs. It was 0.2m high and appears to have been disturbed.

Context No.: 30
Context Type: Layer
 This layer was located on the western side of the wall. It was a buff coloured sandy surface, composed of compressed beach sand. This appears to be the floor of the structure.

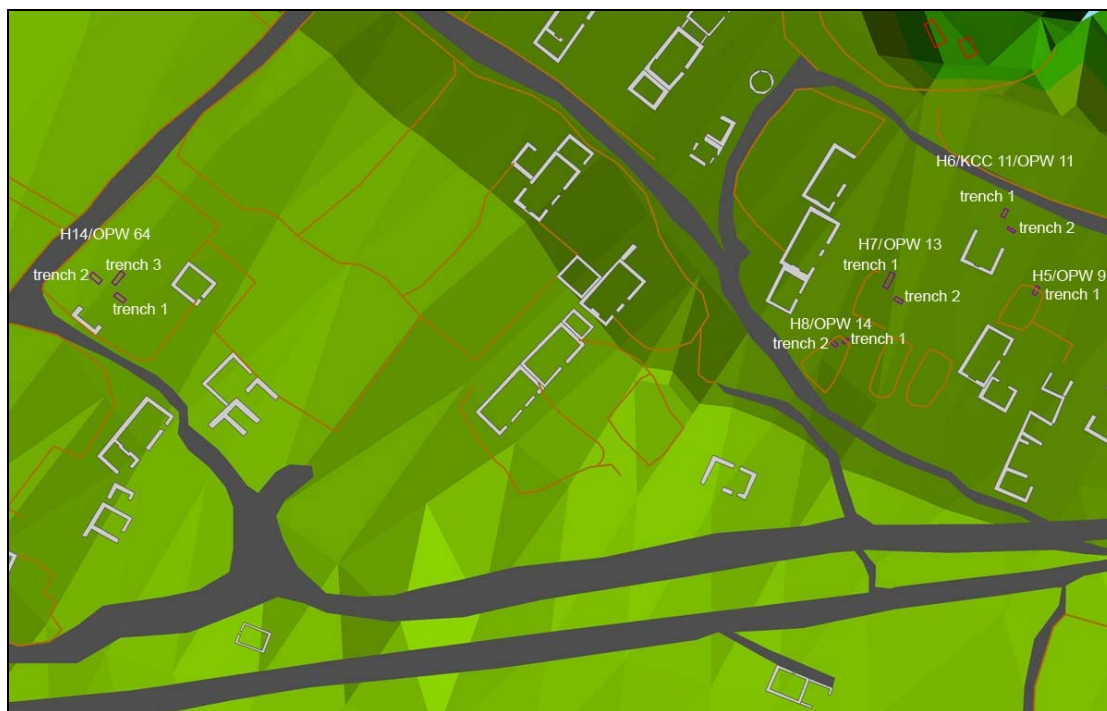
Figure 54. Plan of house and test trench locations

Three trenches were opened at this site, on the northern, eastern and southern sides. The trench at the northern side did not reveal any trace of a wall. However, the wall was located in the eastern and southern trenches, as was evidence of a sandy floor surface.
